CONSERVATION PROPOSAL FOR ST. JAMES' CHURCH

Prepared by
INTACH Delhi Chapter
71, Lodi Estate, KK Birla Lane, New Delhi-110003

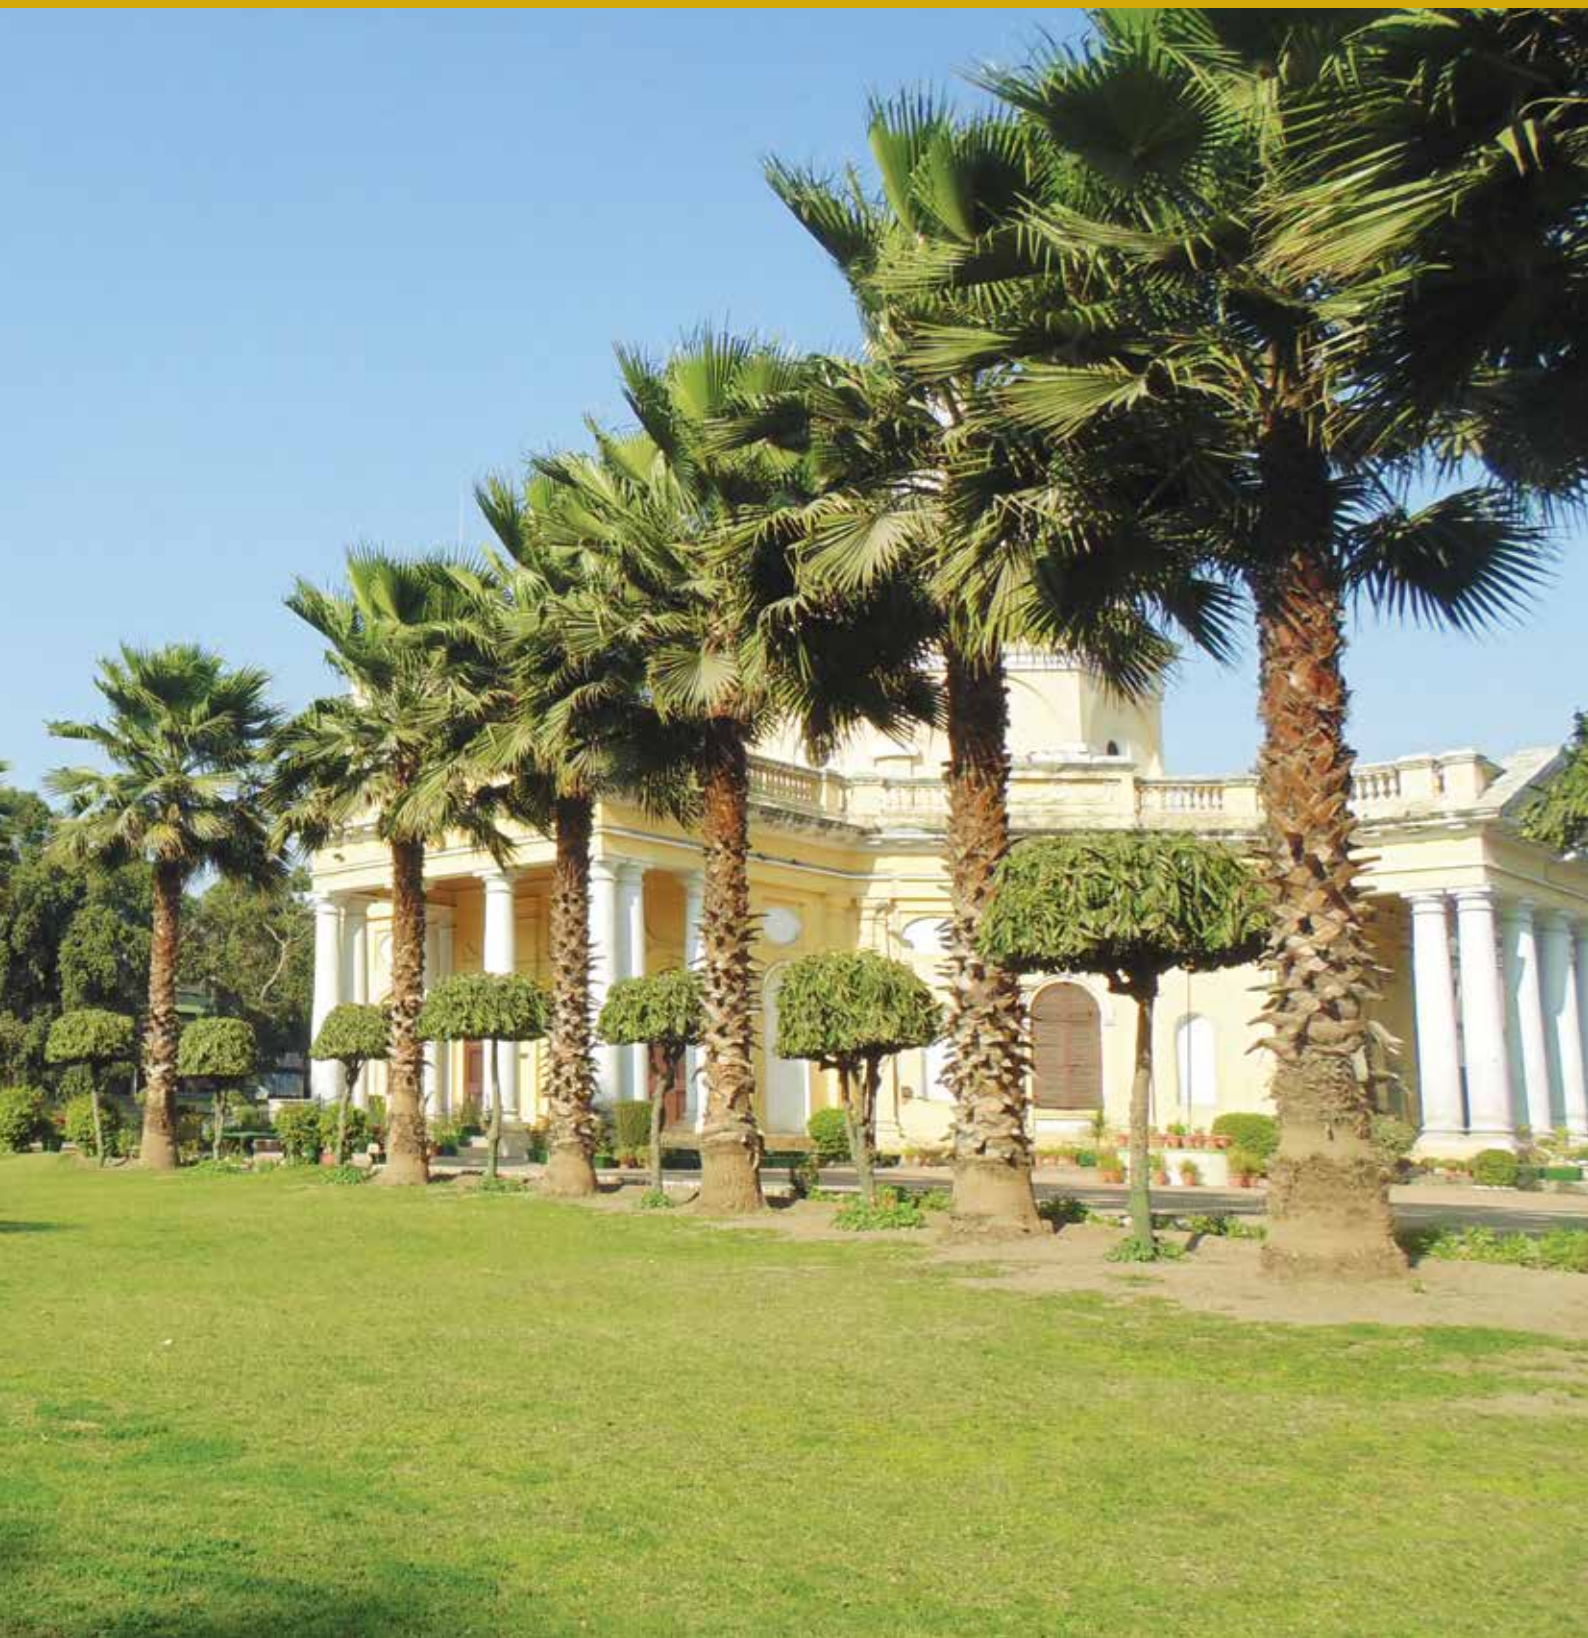
Great care has been taken in the compilation, updation and validation of the information, and every effort has been made to ensure that all information is up-to-date during the submission of this Conservation Statement. Sources for information and photographs have been mentioned wherever necessary until and unless the drawings have been prepared and photographs clicked by the Team of INTACH Delhi Chapter.

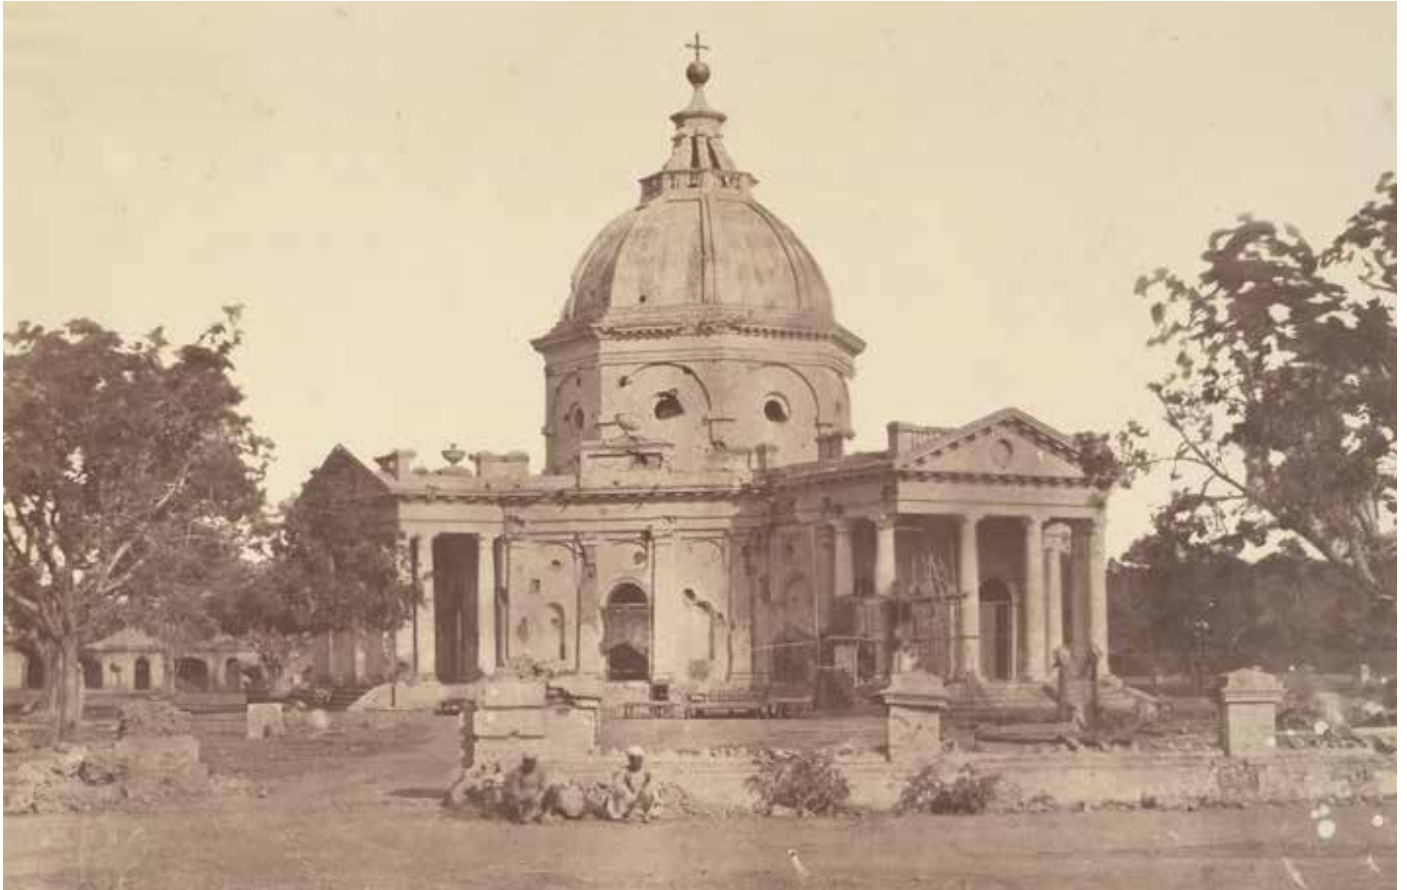
Pic 02: Damage caused during Mutiny, 1857. Source: John Murray Collection

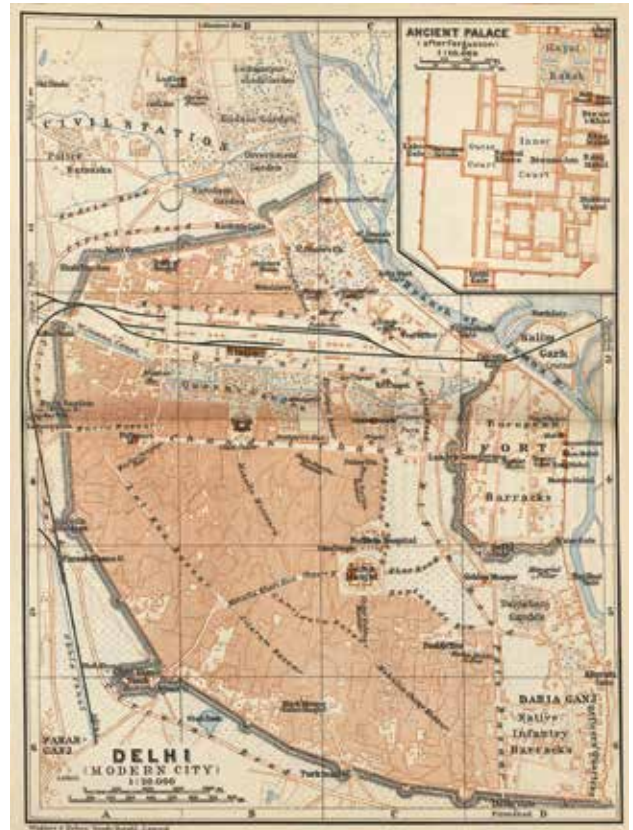
Map 01: Delhi 1914, map of wagner & Debes
Source: www.lib.utexas.edu

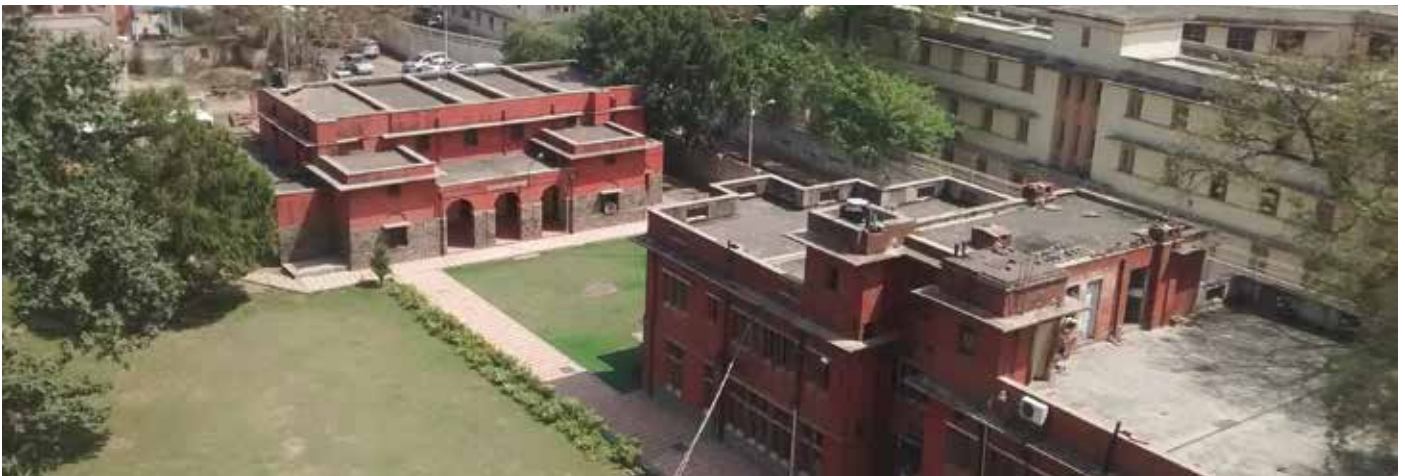
Pic 03: View of Church complex from terrace showing parish hall, old age home and I.S.P.C.K offices.

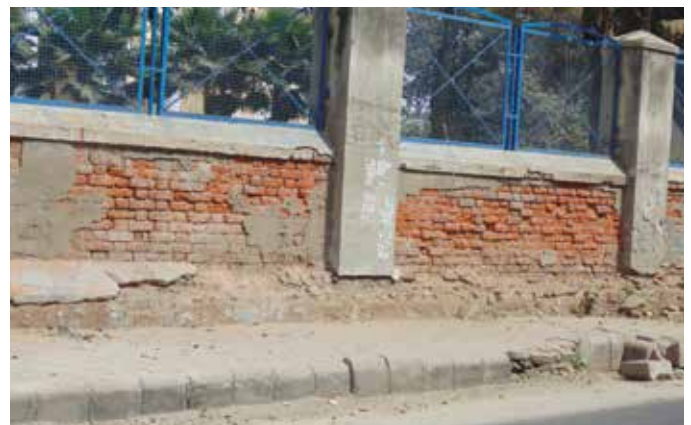
Pic 05: Present Boundary Wall of the Church Complex from Lothian Road

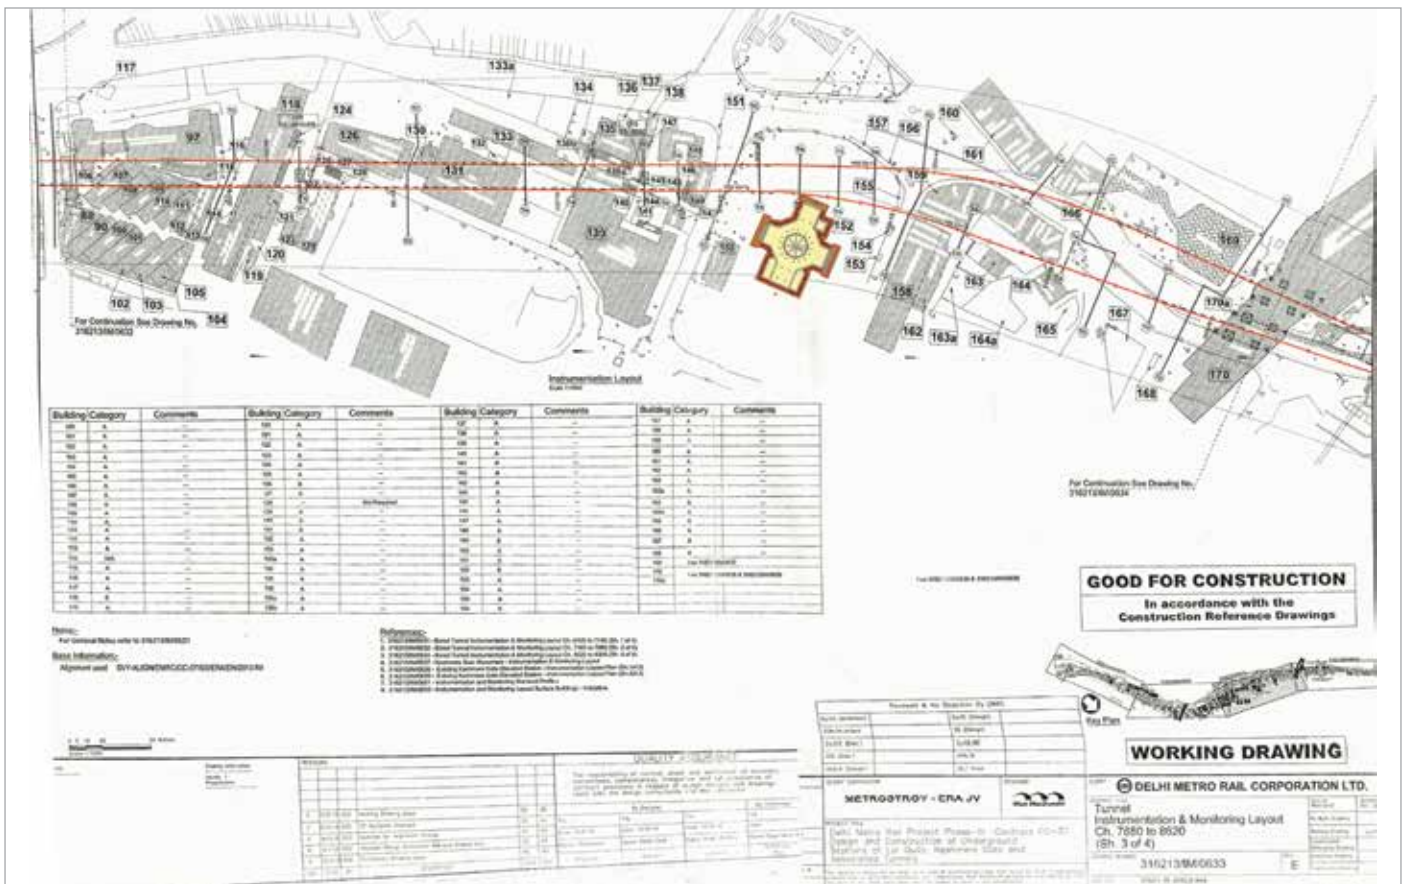
Fig. 01: Proposed Metro line passing by the structure

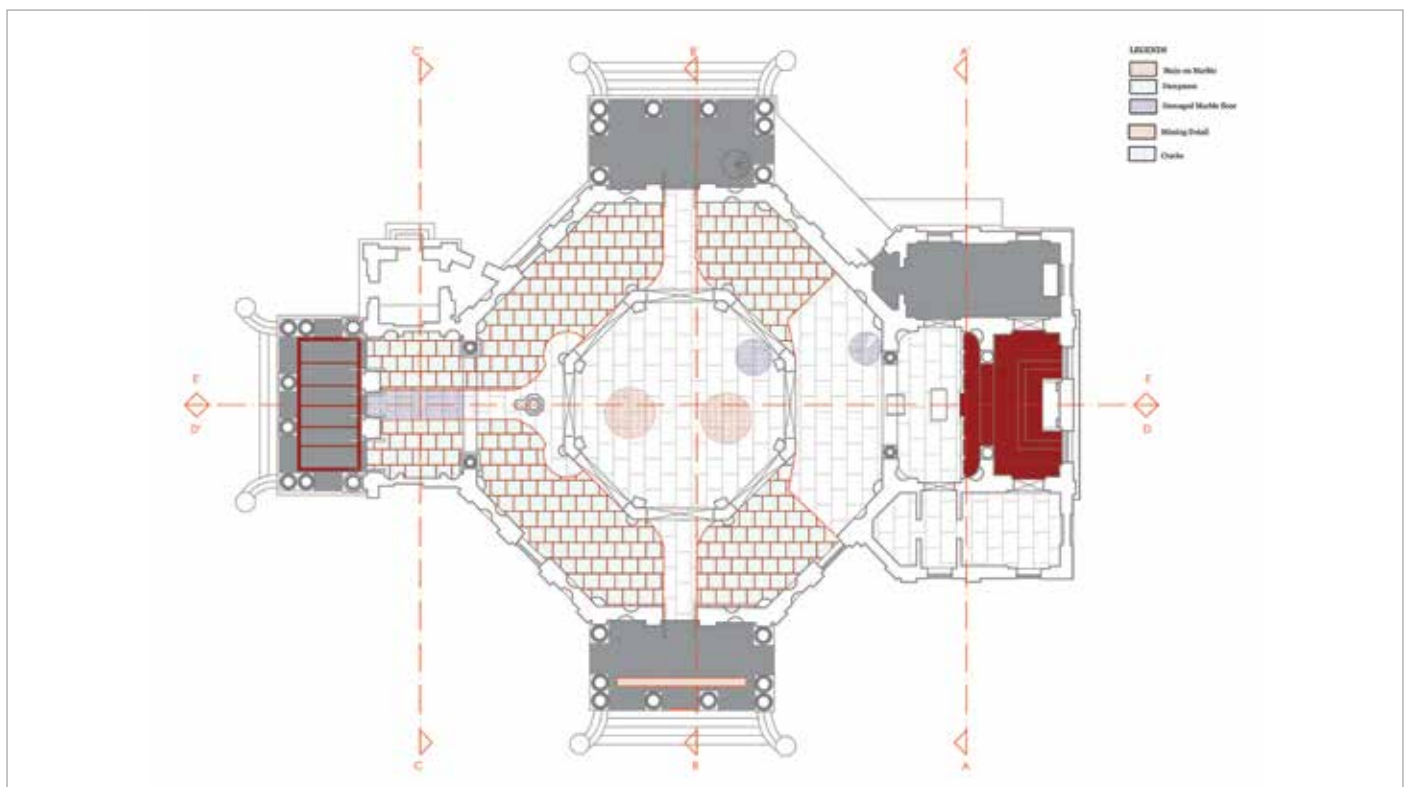
Fig. 02: Condition assessment of the Interior

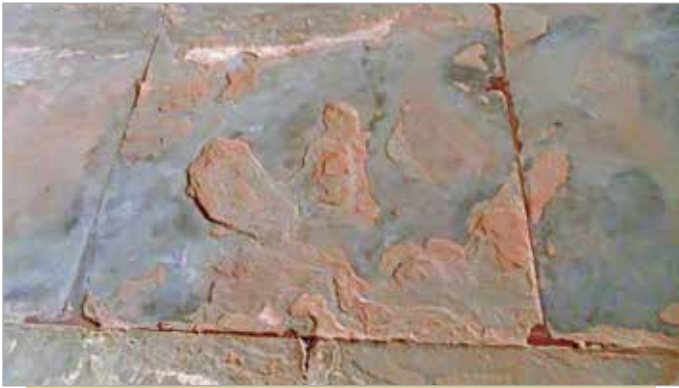
Pic 06: Weathered Red Sandstone

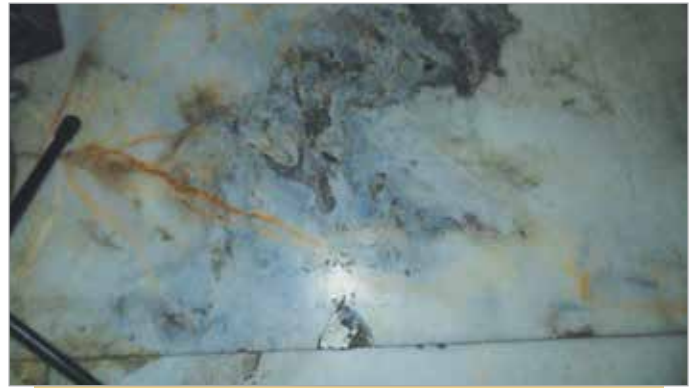
Pic 07: Staining of marble flooring near Lactern

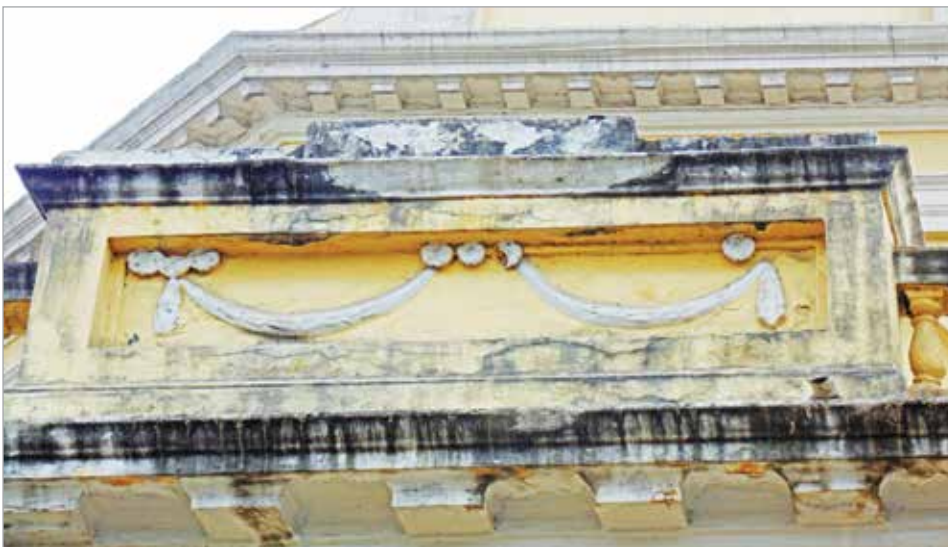
Pic 08: Black spotting on parapet and disfigured mouldings

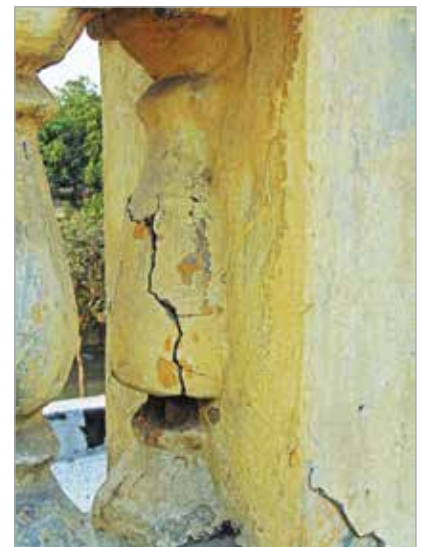
Pic 09: Damaged balusters

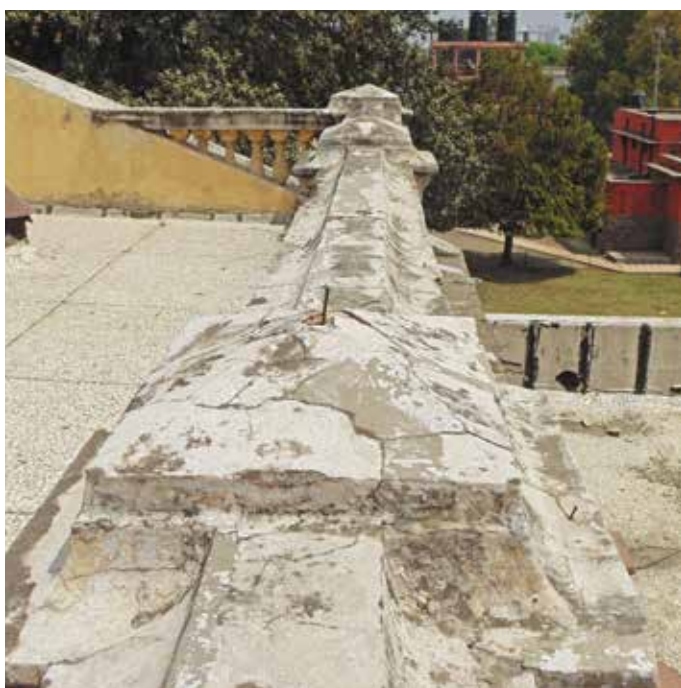
Pic 10: Damaged surface of parapet wall

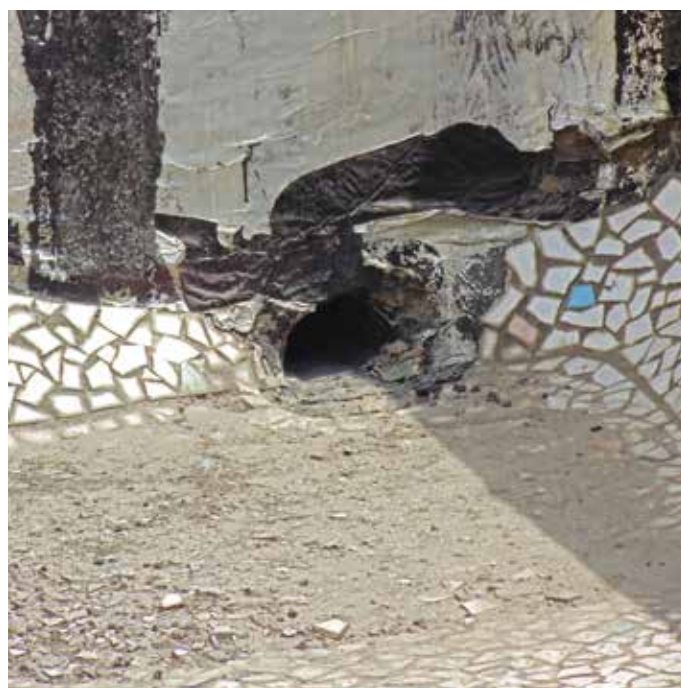
Pic 11: Blocked rain water pipes

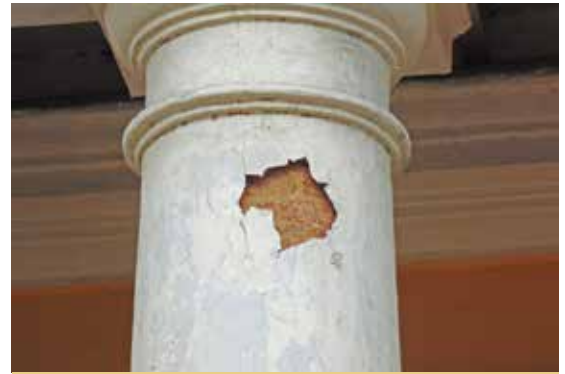
Pic 12: Exposed masonry on columns

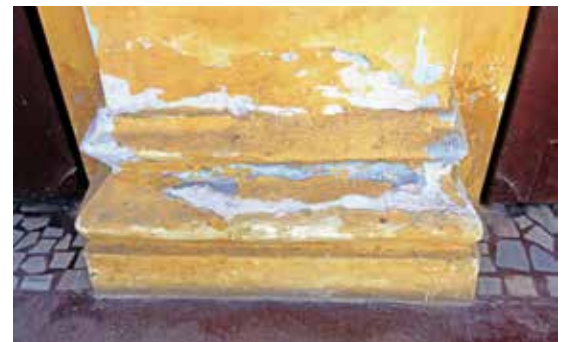
Pic 13: Damaged lime-wash on walls

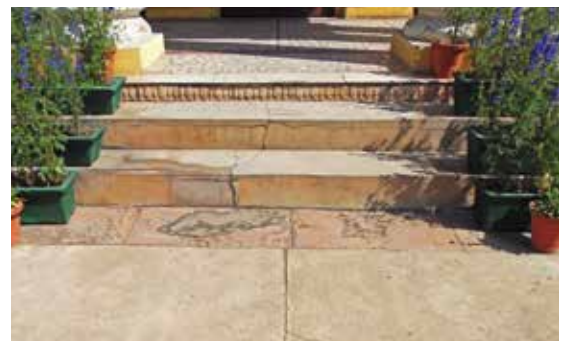
Pic 14: Damaged steps of western portico

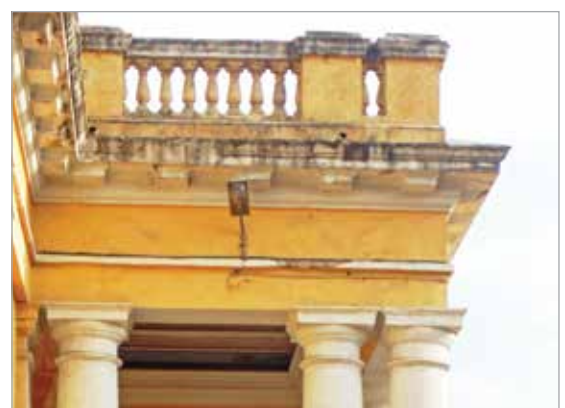
Pic 15: Black spotting and dampness on wall and moulding surface

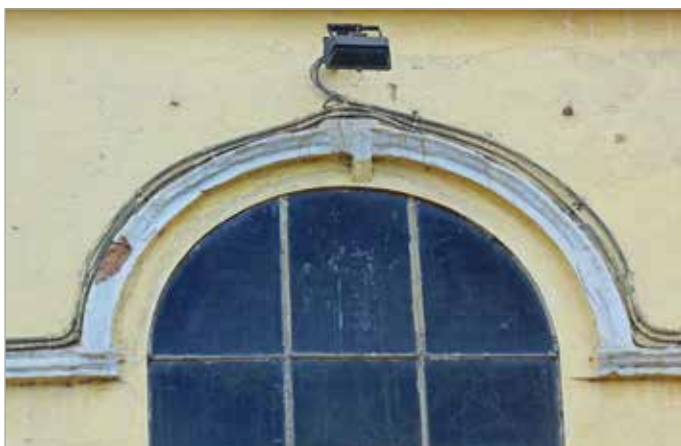
Pic 16: Damaged mouldings due to exposed electrical conduiting and fixtures

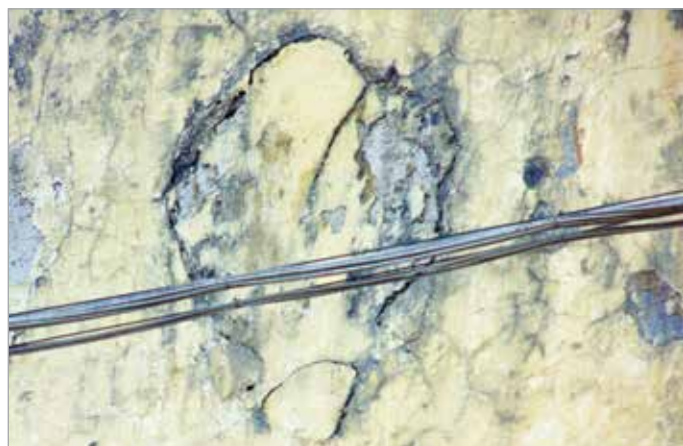
Pic 17: Bulging of plaster

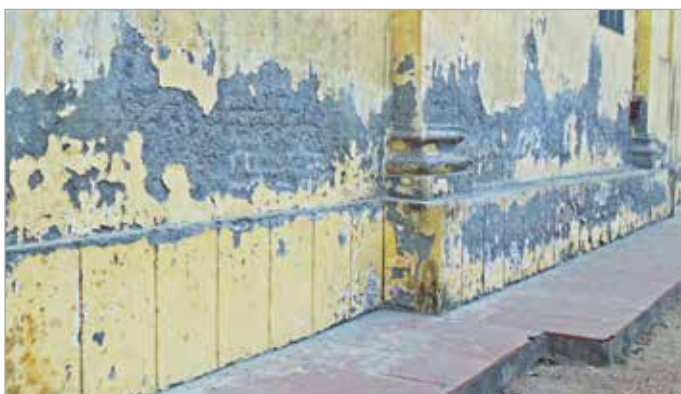
Pic 18: Damaged plaster and on walls

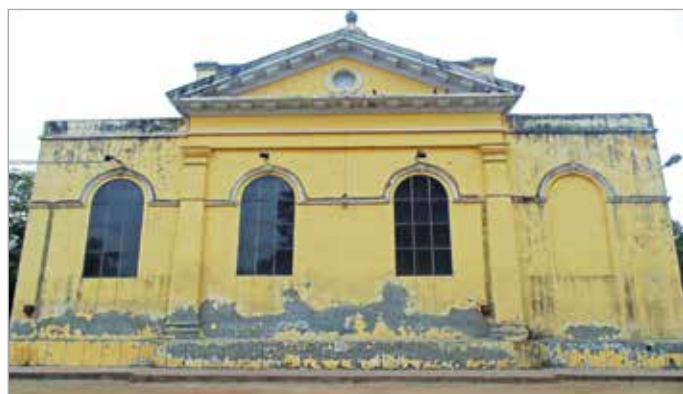
Pic 19: View of Eastern facade

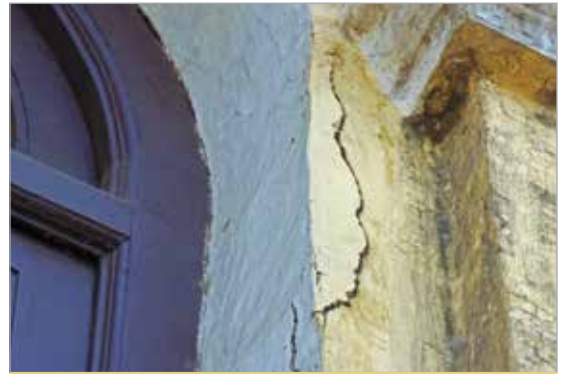
Pic 20: Cracked plaster of walls

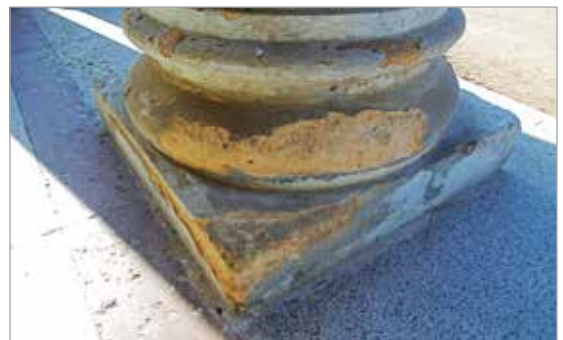
Pic 21: Flaked plaster on columns

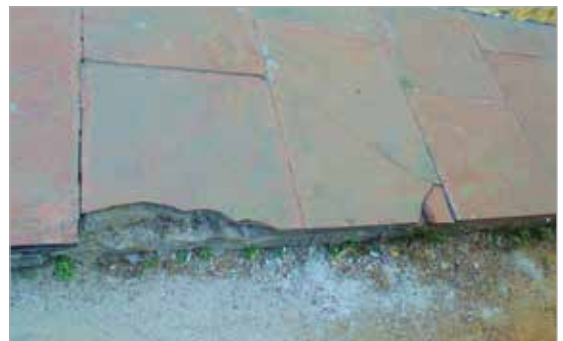
Pic 22: Broken red sandstone slabs of plinth

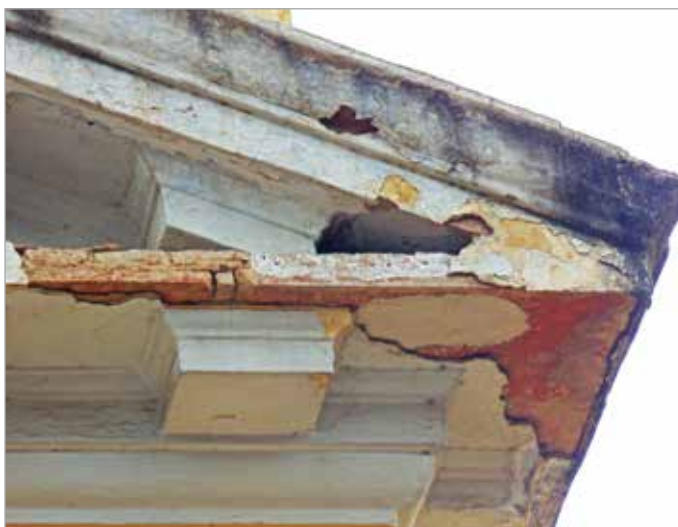
Pic 23: Damaged cornice mouldings

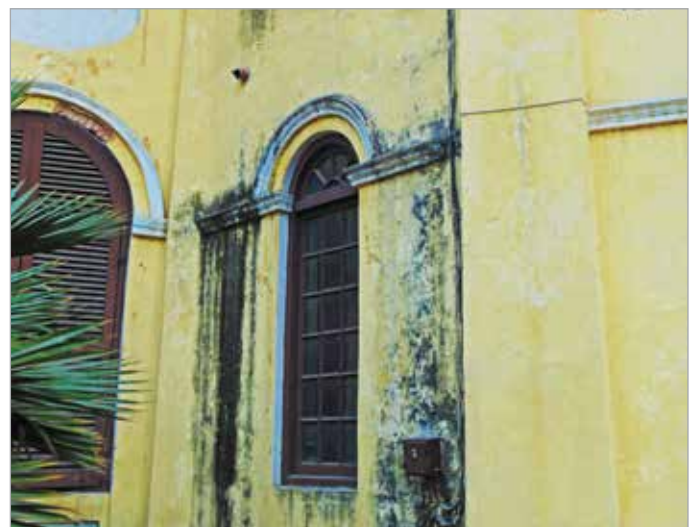
Pic 24: Black spotting and flaking on mouldings

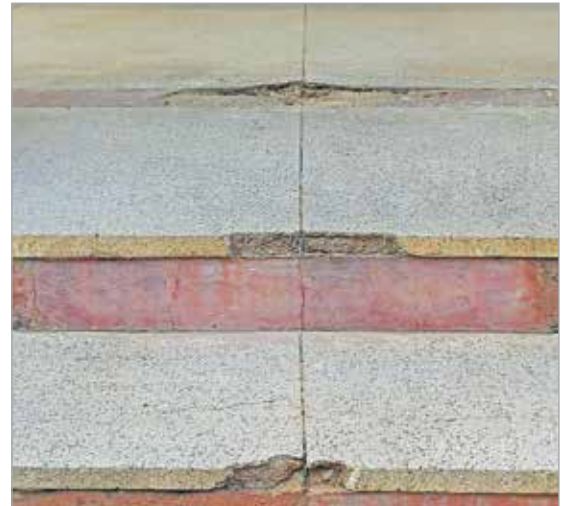
Pic 25: Damaged entrance steps

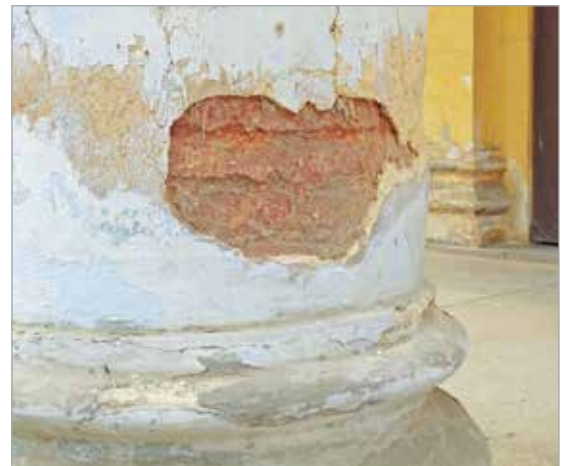
Pic 26: Exposed masonry on columns

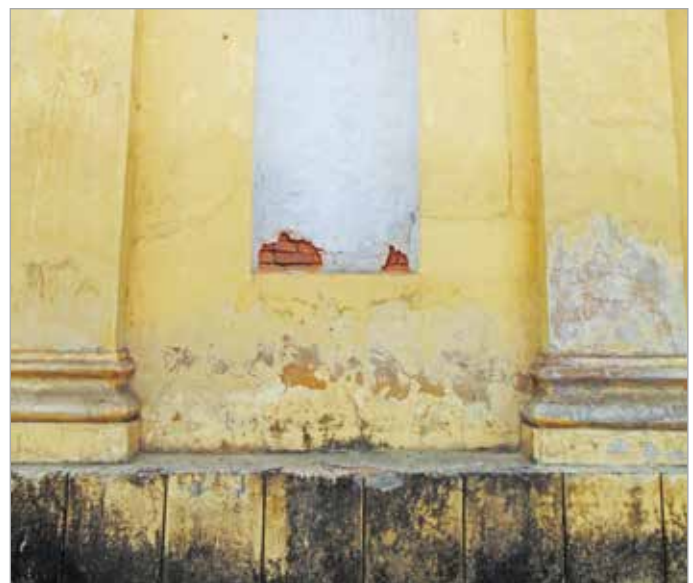
Pic 28: Black spotting and damaged plaster on pilasters and plinth surface

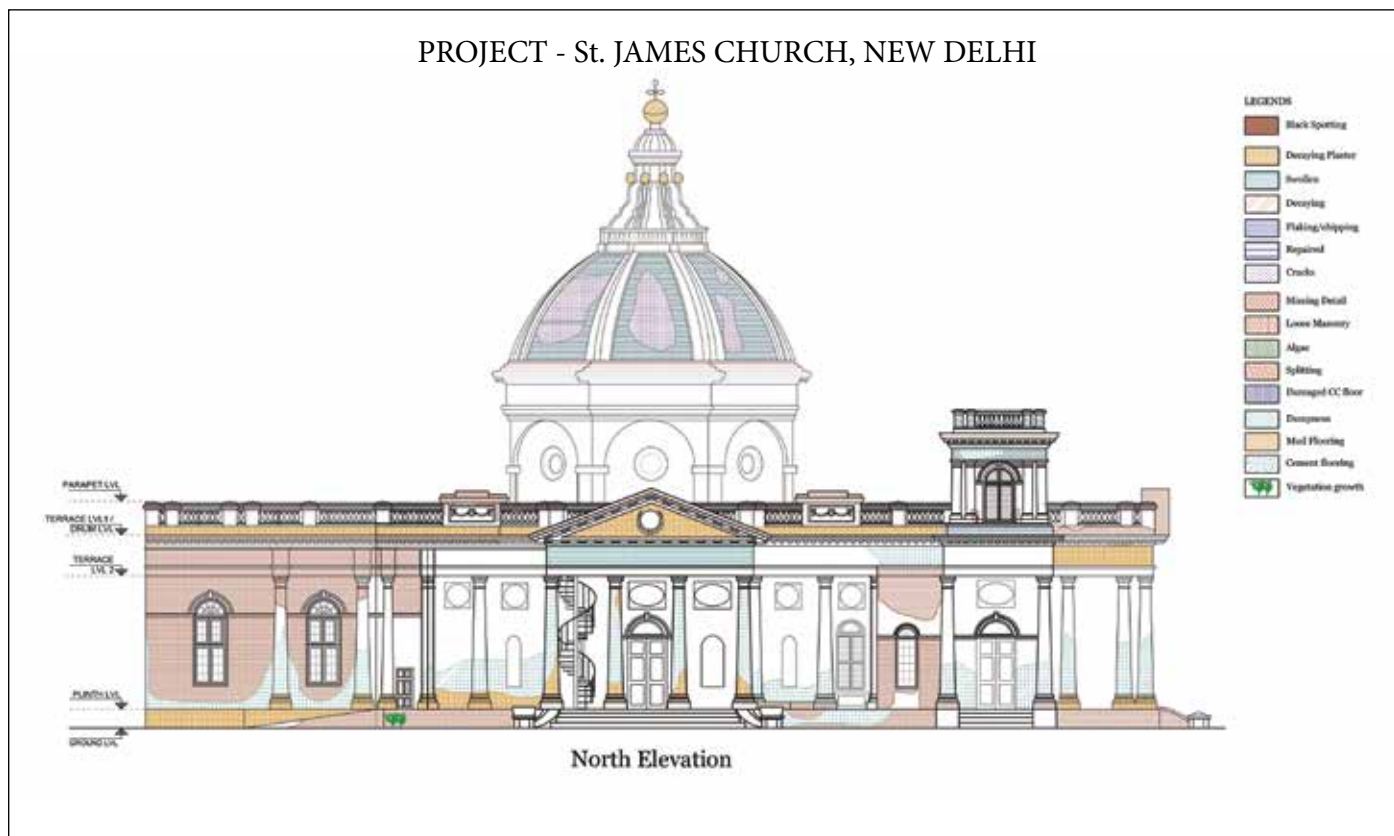
Fig. 03: Condition assessment of North Elevation

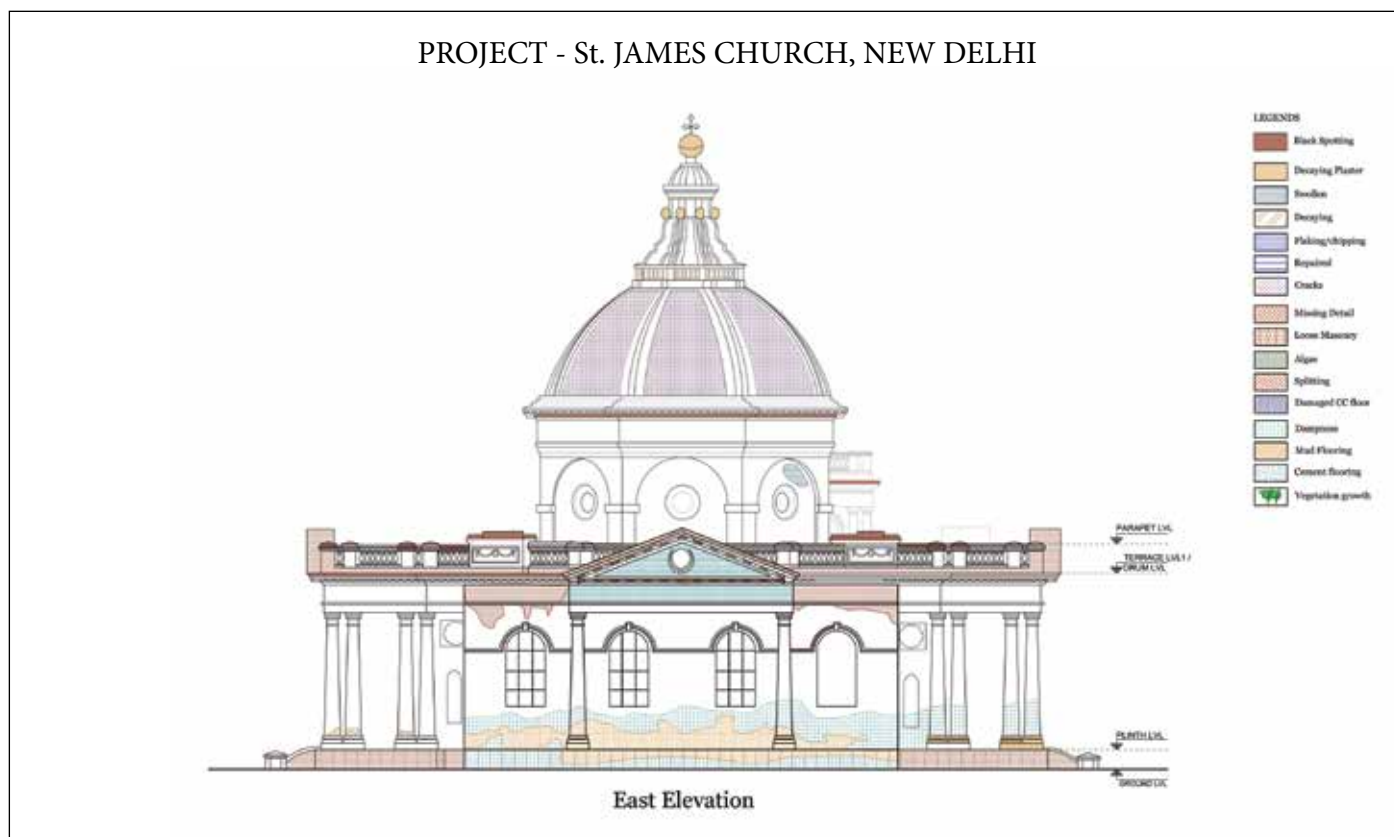
Fig. 04: Condition assessment of East Elevation

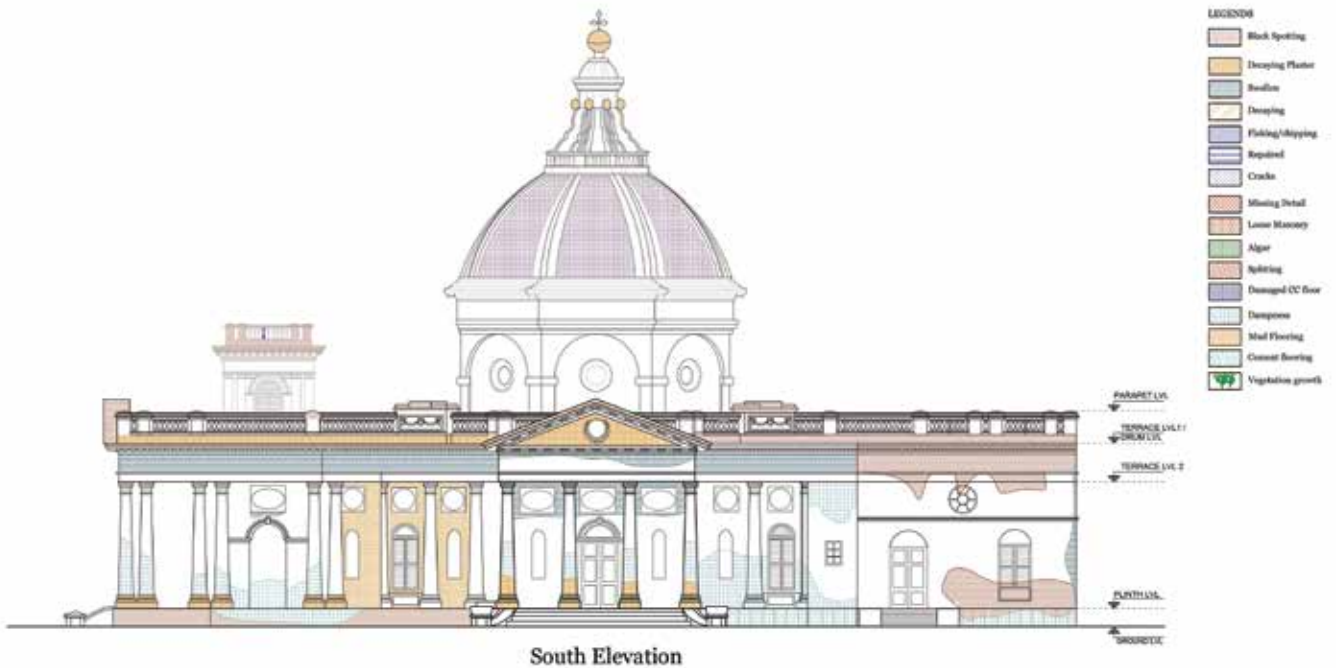
Fig. 05: Condition assessment of South Elevation

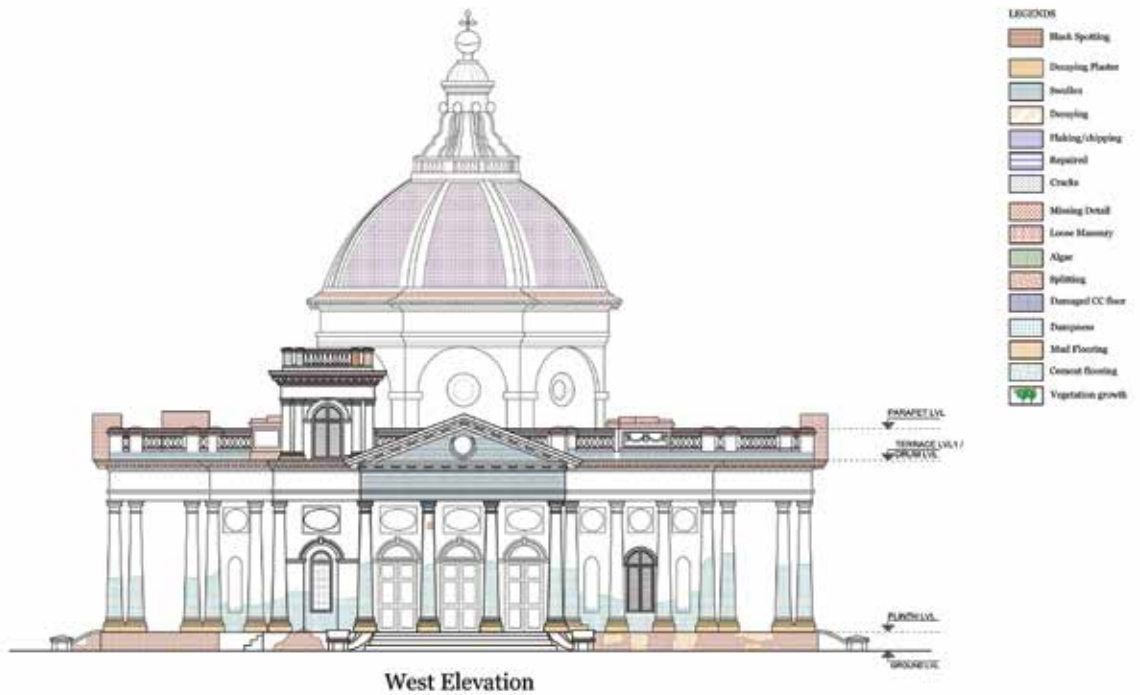
Fig 06: Condition assessment of West Elevation

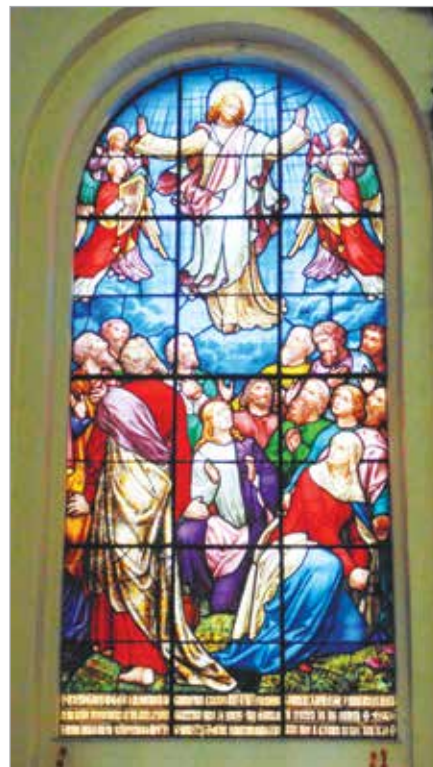
Pic 33: The depiction of the 'Ascension of the Christ' on Left stained glass window

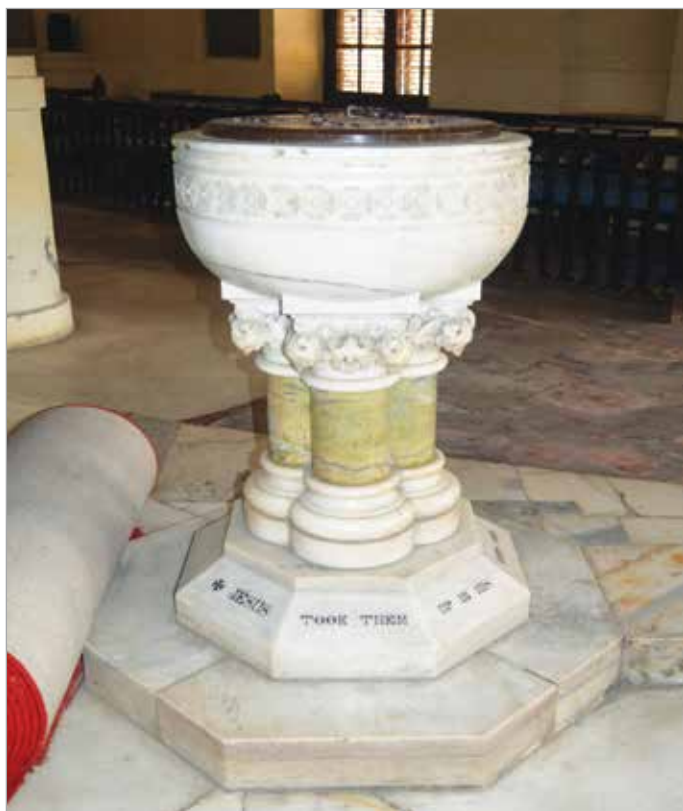
Pic 34: The Marble Font
